CITY OF BALTIMORE SMOKE TESTING OBSERVATION SUMMARY JONES FALLS SEWERSHED

BALTIMORE CITY PROJECT 994 REI/DRAYCO

Unique Test ID: 359	Date: 07/03/2008	Basin: JF-19
Defect No: OB01	Supervisor: E.R.	Dye Test Recommended: N
House No: 2500	Street Name: MARYLAND	Street Type: AVE.
Source Type: 03	Location: 01	Severity: 03
Sector: 02	Drainage Area: 1

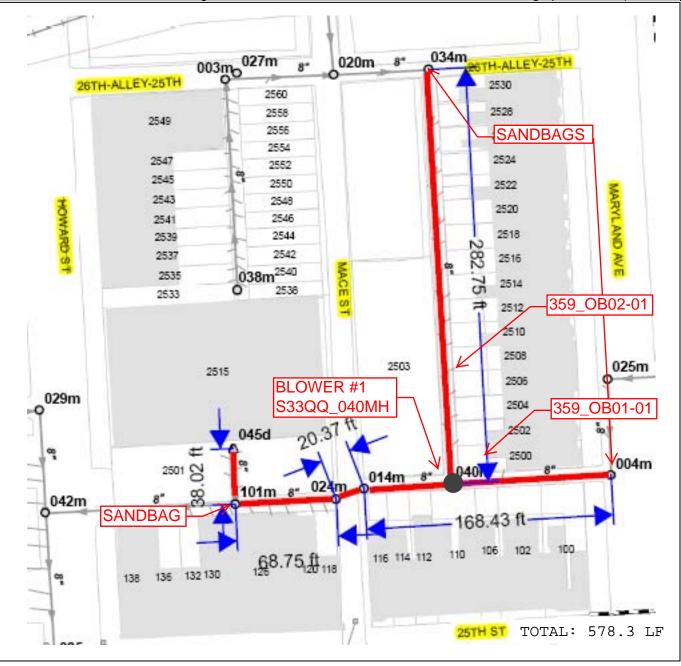
Field Sketch: (Show All Manholes with Numbers, Blower Placement Location, Sandbag or Isolation Locations, Street Names, Building Addresses and Locations, Defect Locations and Photograph Numbers)

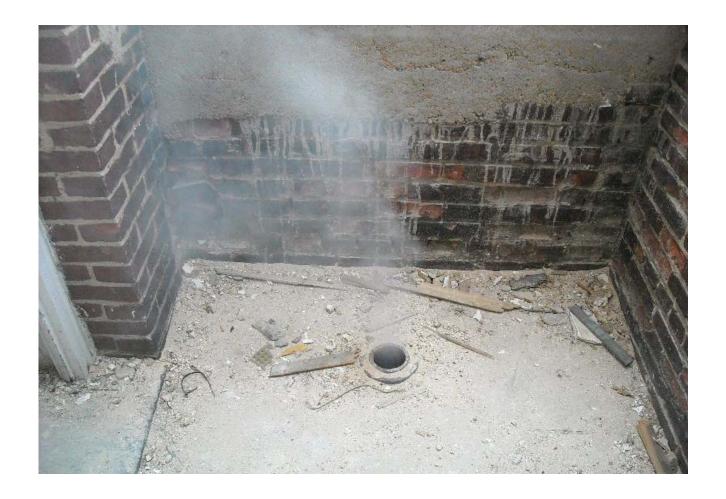
Photograph No: OB01-01 Filename: 0994-359_OB01-01.jpg

Comments: CLEAN OUT - AT GRADE - MISSING CAP

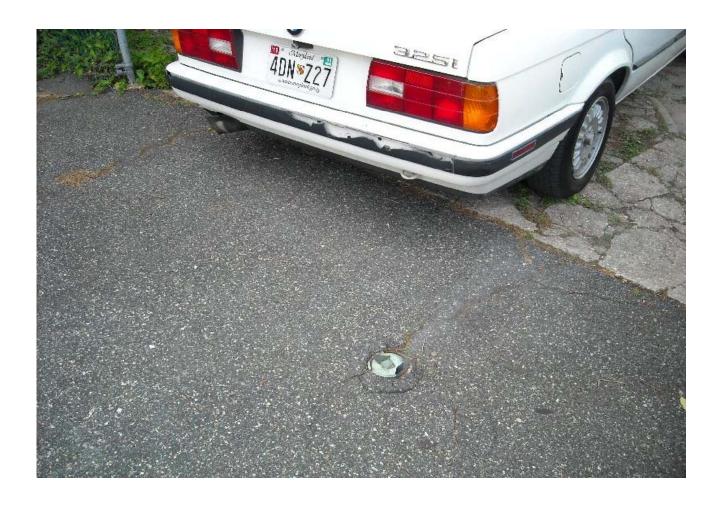
Photograph No: OB02-01 Filename: 0994-359_OB02-01.jpg

Unique Test ID: 359	Date: 07/03/2008	Basin: JF-19
Defect No: OB02	Supervisor: E.R.	Dye Test Recommended: N
House No: 2508	Street Name: MARYLAND	Street Type: AVE.
Source Type: 03	Location: 12	Severity: 02
Sector: 01	Drainage Area: 1

Comments: CLEAN OUT - AT GRADE - BROKEN CAP
